### **APPENDIX 17A**

### Key Observation Points for the Enhanced Bus Service and Gondola Alternatives

VISUAL CONTRAST RATING WORKSHEET																		
															Activ	ity (program) N/A			
								SE	ECTIC	A NC	. PRC	JEC	ΓINF	ORMATION					
1. Project Improver	Name: Little Cottonw nents	cccd C	anyoni	Wasa	tch Bl	<i>r</i> d to A	lta Tra	nspor	tation							on Sketch e in ElS section

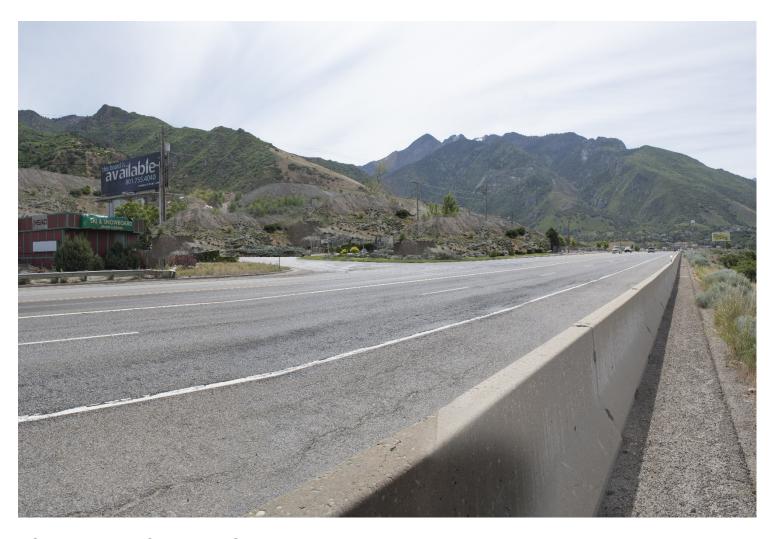
KOP 1 - Existing Condition - Gravel Pit Mobility Hub

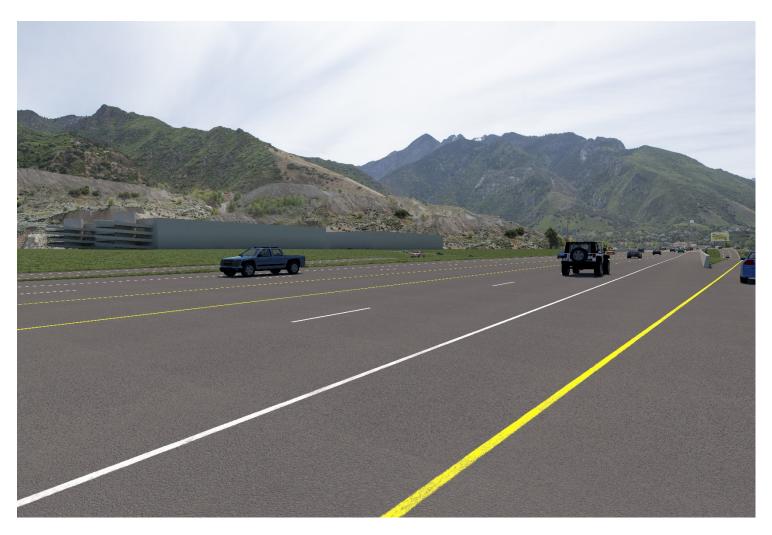
KOP 1 - Proposed Condition - Gravel Pit Mobility Hub (All Alternatives)

1. L/	NATE	₹					2. VEGETATION 3. STRUCTURES											
FORM		Trapezoidal, mounded, exposed aggregate backdrop with rugged, undulating broken ridges										Domestic vegetation plantings; short and low indistinct grasses; rounded low shrubs at foot of mound; rounded oak shrubs; conical evergreens on ridge							
LINE	mound/mount ridgelines	veral horizontal lines from tiered bund/mountain ridgelines; rugged broken gelines									Distinct lines between dense vegetation and low grasses or exposed soil/aggregate  Varied angles and orientations; complex								
80700		tan exposed rock to pinkish tones; d light tan to gray aggregate									Gray green sage; yellowish to dark green shrubs; lime to golden straw-colored grasses Green and brown building; grays, blues, beige, yellow throughout complex; earth tones								
-XII-	Distinct, smooth, uniform, and patterned soil; rugged, broken landforms in background									Clustered and organized; low stippled, broken sage groupings; consistent carpeted grasses; dense clusters of domestic vegetation with varied heights

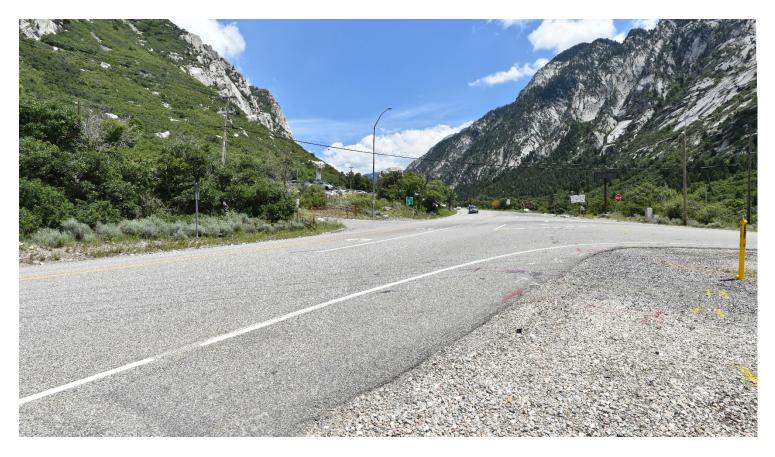
KOP 4 - Existing Condition - Quarry Trailhead

3. VRM	3. VRM Class N/A																	
SECTION B. (											TERIS	STIC	LANI	DSCAPE DESCRIPTI	ON			
	1. LAND/WATER											2. VI	GETA	ATION	3. STRUCTURES			
FORM	Rugged, broken canyon faces; rounded, irregular cliffs; distinct spines and angled, linear drainages transition to chunky, broken, exposed granite walls; tiered parking lot set								forest; some indistinct shrubs and low upright s grasses cables or						Flat, horizontal roadway; some geometric, upright signage; horizontal transmission cables overhead attached to upright, vertical utility poles			
ENE	Irregular and ir undulating, bro	above roadway Irregular and inconsistent rock bands; undulating, broken ridgeline; directional breakage along diff face									morphic lines created by tree groupings; istinct lines between dense vegetation and exposed cliff  Curvilinear roadway; horizontal and vegetation and exposed cliff							
COLOR	Whitish-gray diffs with dark gray to black vertical striations														Dark gray asphalt; natural wood utility poles; gray cables and energy infrastructure

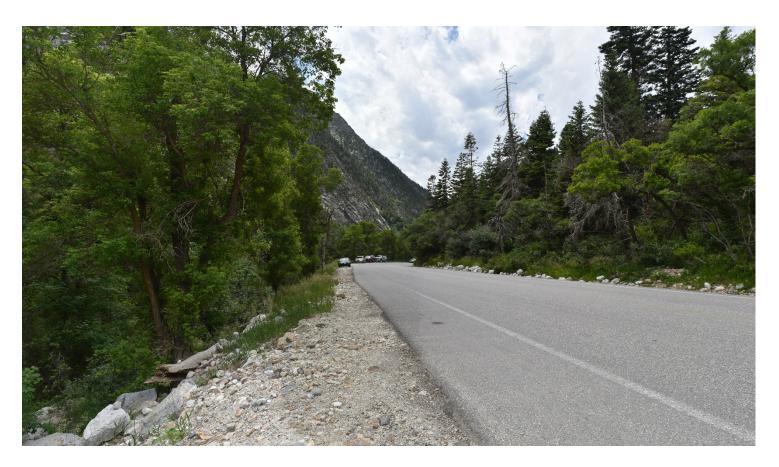
KOP 7 – Existing Condition – Bridge Trailhead

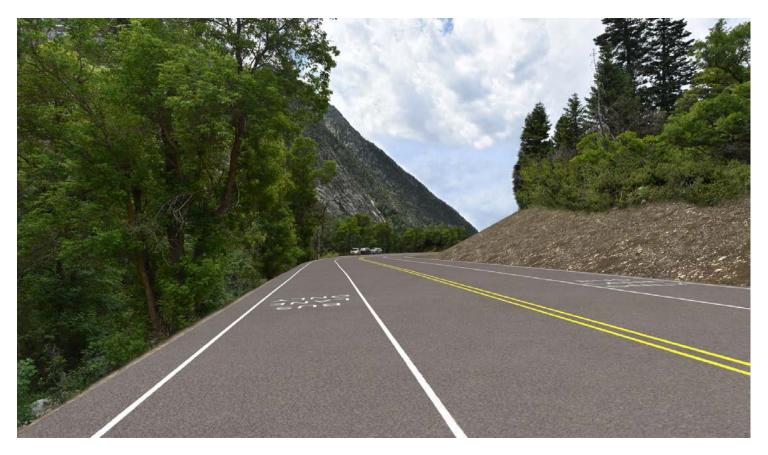
KOP 7 – Proposed Condition – Bridge Trailhead (Enhanced Bus Service in Peak-period Shoulder Lane Alternative)

1. L	ANDA	NATE	R								2. VI	EGETA	ATION		3. STRUCTURES			
No perceived change.									No pe	erceiv	ved c	hang	je.		Upright, vertical geometric towers with angular and vertical components; linear continuous cables; geometric gondola cabins				
EINE	No perceived o	hang	e.					1	No pe	erceiv	ved c	hang	je.		Bold vertical rigid tower; intersecting perpendicular lines; continuous cables				
COLOR	No perceived o	hang	e.					ı	No pe	erceiv	ved c	hang	je.			Galvanized steel; dark tones of gondola cabins			
No perceived change.									No pe	erceiv	ved c	hang	je.			Rigid broken inconsistent tower; continuous fine cables; repetitive gondola cabins			
					S	ECTI	ON E	). CC	NTR	AST	RATI	NG E	] SH	ORT TERM X LO	ONG TE	RM

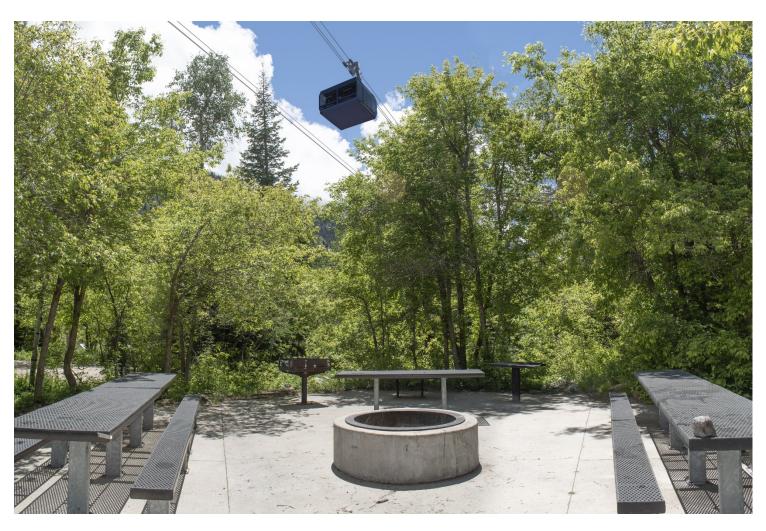
KOP 9 - Proposed Condition - Tanners Flat Group Site C (Gondola Alternative)

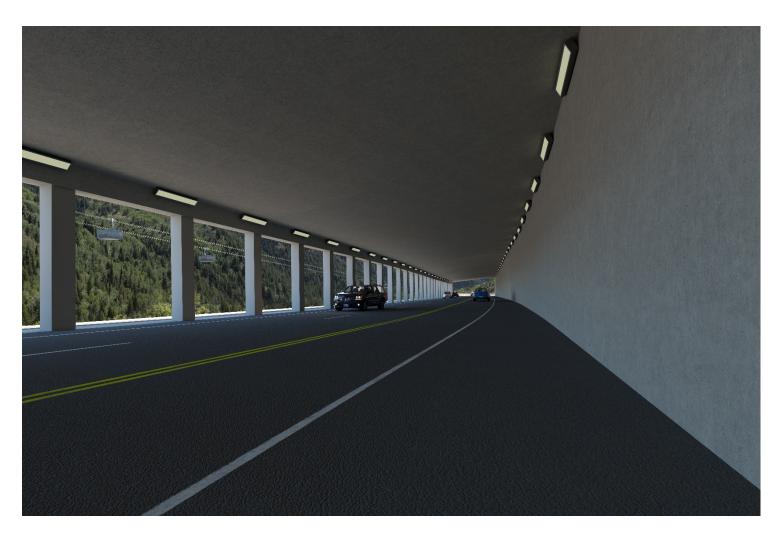
KOP 11 - Proposed Condition - Southwest Toward Tanners Flat (S.R. 210) (Gondola Alternative)

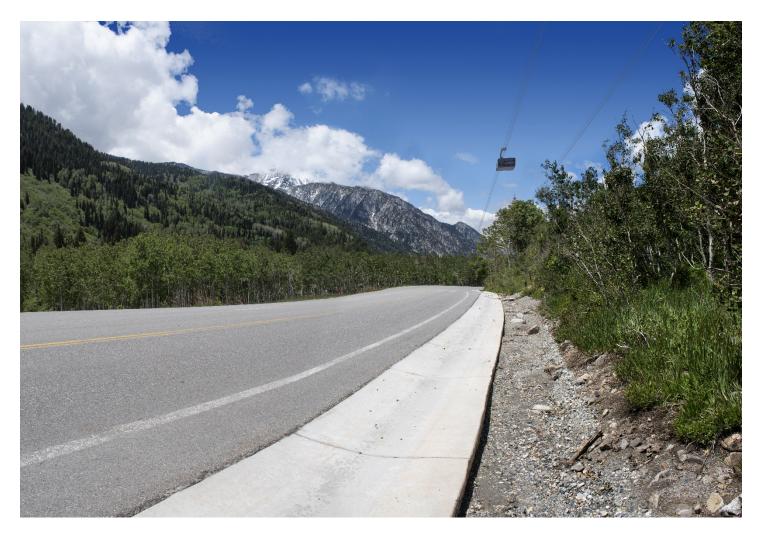
KOP 16 - Proposed Condition - White Pine Trailhead (Gondola Alternative)

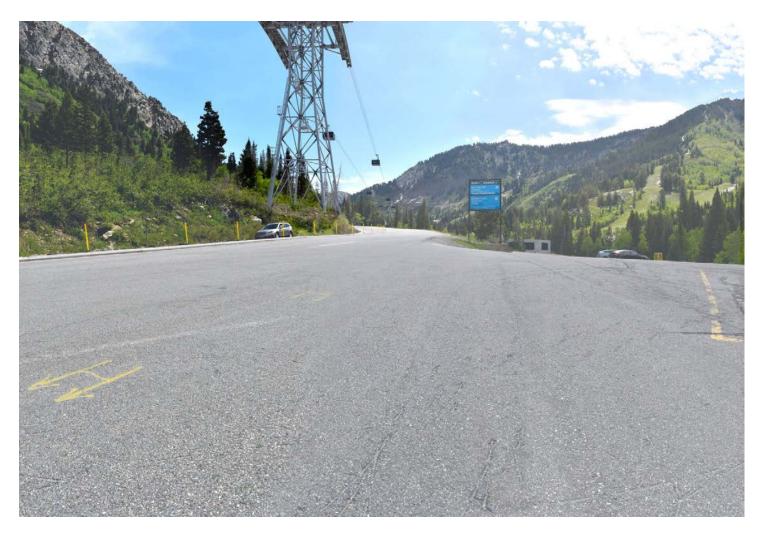
KOP 18 - Proposed Condition - Snowbird Entry 1 (Gondola Alternative)

- INE	No perceived o	thang	ge.					ı	No pe	erceiv	ved cha	ange.			Bold, vertical, rigid; intersecting perpendicular lines; continuous cables					
COLOR	No perceived o	hanç	ge.					ı	No p	erceiv	ved cha	ange.			Galvanized steel; dark tones of gondola cabins					
TRE	No perceived o	thang	ge.					I	No pe	erceiv	ved cha	ange.			Rigid, broken, inconsistent towers; continuous fine cables; repetitive gondola cabins					
		_	_	_	5	SECT	ION	D. CC	ONTF	RAST	RATIN	IG□	SHO	RT TERM X LONG T	ERM

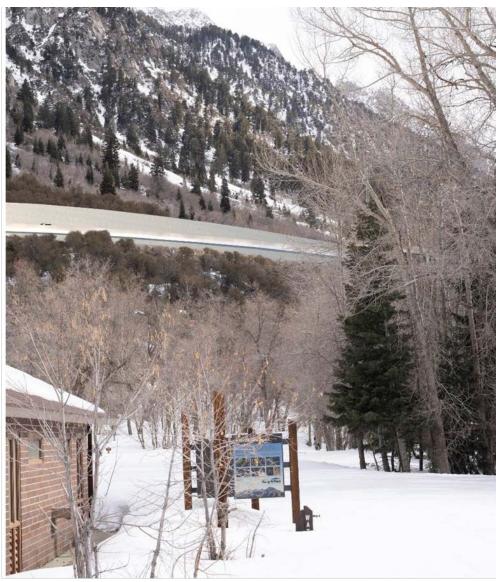
KOP 25 – Proposed Condition – Tanner's Flat Campground (Enhanced Bus Service Alternative and Enhanced Bus Service in Peak-period Shoulder Lane)
