Riparian Habitat Conservation Areas Assessment Memorandum

Project: Little Cottonwood Canyon EIS

Subject: Riparian Habitat Conservation Areas Assessment

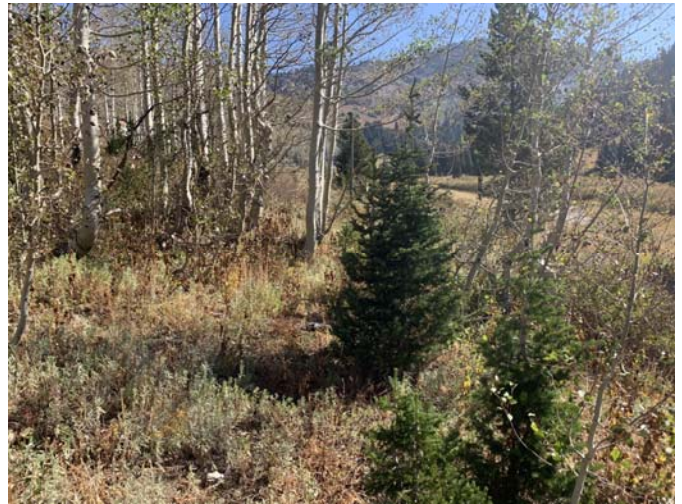
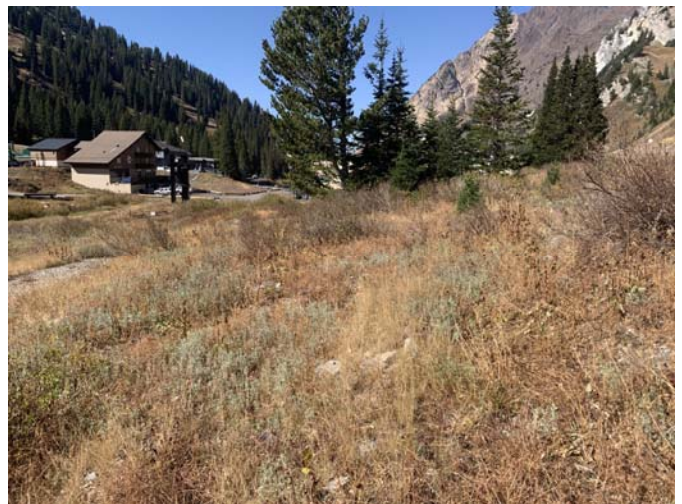
RHCA Field Point 1

RHCA ID	Surveyor	Date	General Notes	Riparian	Successional Stage	Canopy Cover	Dominant Canopy Species	Shrub-Sapling Cover	Dominant Shrub/Sapling Species	Herbaceous Cover	Dominant Herbaceous Species	Invasive/Weedy Species Cover	Dominant Invasive/Weedy Species	Percent Ground Cover	Stream Condition
1	JM	9/24/2020	Some nearby disturbance from trails.	NO	Late	5-25%	<i>Populus tremuloides</i> , <i>Pseudotsuga menziesii</i>	5-25%	<i>Artemisia tridentata</i> , <i>Lonicera involucrata</i> , <i>Prunus virginiana</i>	25-50%	<i>Asclepias syriaca</i> , <i>Solidago canadensis</i>	0%	NA	50-75%	NA
2	JM	9/24/2020	No disturbance within the plot.	NO	Late	25-50%	<i>Picea engelmannii</i> , <i>Pseudotsuga menziesii</i>	0%	NA	50-75%	<i>Erigeron sp.</i>	0%	NA	50-75%	NA
3	JM	9/24/2020	Plot has disturbance with walking trails and a nearby road.	NO	Late	5-25%	<i>Populus tremuloides</i>	5-25%	<i>Populus tremuloides</i>	25-50%	<i>Bromus inermis</i> , <i>Solidago canadensis</i>	0%	NA	25-50%	Stream has some disturbance with boulders from road stabilization. Areas downstream are in good condition.

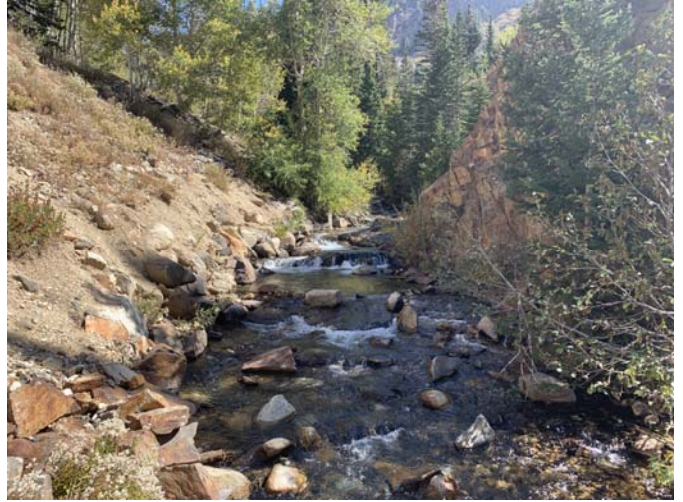
RHCA Field Point 4

RHCA ID	Surveyor	Date	General Notes	Riparian	Successional Stage	Canopy Cover	Dominant Canopy Species	Shrub-Sapling Cover	Dominant Shrub/Sapling Species	Herbaceous Cover	Dominant Herbaceous Species	Invasive/Weedy Species Cover	Dominant Invasive/Weedy Species	Percent Ground Cover	Stream Condition
4	JM	9/24/2020	Disturbance from rock slides from trail above.	Yes	Late	5-25%	<i>Populus tremuloides</i> , <i>Pseudotsuga menziesii</i>	5-25%	<i>Salix bebbiana</i> , <i>Cercocarpus ledifolius</i> Nutt.	5-25%	<i>Solidago canadensis</i>	0%	NA	25-50%	Stream is in relatively good condition with some disturbance from trail. Thin riparian layer on each side of the stream approximately 5 feet.
5	JM	9/24/2020	Cottonwood stand above roadside drainage.	Yes	Late	5-25%	<i>Populus tremuloides</i>	25-50%	<i>Salix bebbiana</i> , <i>Cercocarpus ledifolius</i> Nutt.	25-50%	<i>Solidago canadensis</i>	5-25%	<i>Phragmites australis</i>	50-75%	Riparian vegetation along drainage. No riparian layer on south side of road.

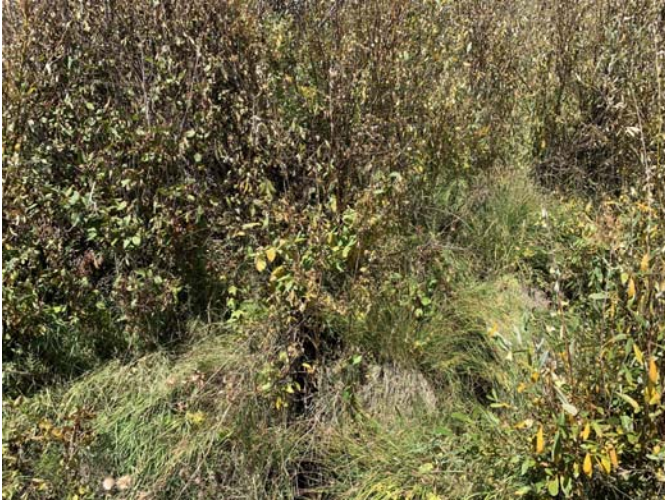
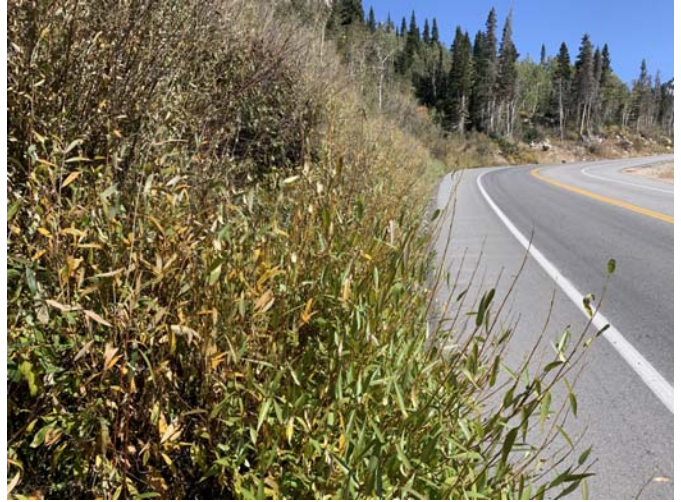
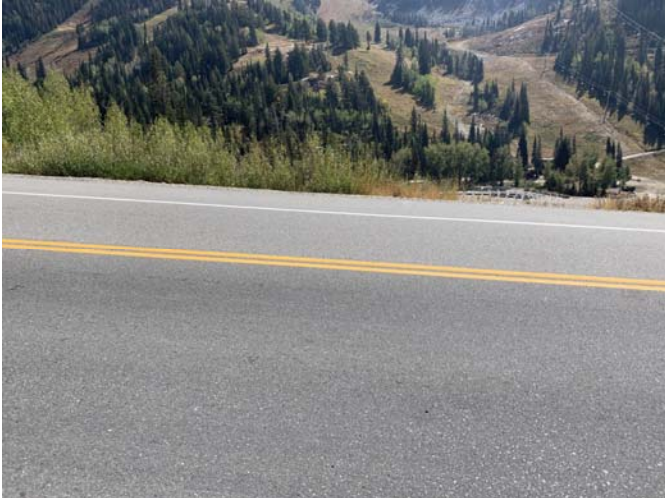
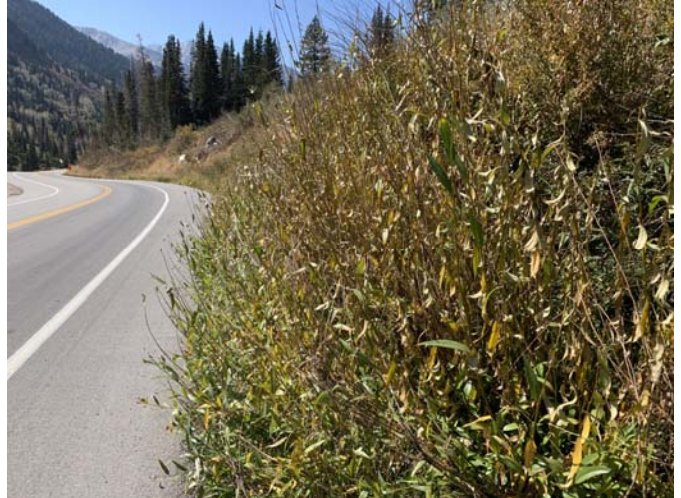
RHCA Field Point 6

6	JM	9/24/2020	Site doesn't appear to be disturbed.	Yes	Late	5-25%	<i>Populus tremuloides</i> , <i>Acer negundo</i>	50-75%	<i>Salix bebbiana</i> , <i>Acer negundo</i>	25-50%	<i>Bromus inermis</i>	5-25%	<i>Cirsium sp.</i>	75-95%	Stream doesn't appear to be disturbed. Small intermittent channel. Somewhat channelized.
12	JM	9/24/2020	Site doesn't appear to be disturbed.	Yes	Late	50-75%	<i>Populus tremuloides</i> , <i>Populus angustifolia</i>	25-50%	<i>Cercocarpus ledifolius</i> Nutt.	25-50%	NA	0%	NA	50-75%	Intermittent stream channel with a few cottonwoods. Stream appears to be in good condition.
14	JM	9/24/2020	Plot is undisturbed.	Yes	Late	50-75%	<i>Populus angustifolia</i> , <i>Populus tremuloides</i>	25-50%	<i>Populus tremuloides</i> , <i>Symphoricarpos oreophilus</i> , <i>Prunus virginiana</i>	5-25%	<i>Bromus inermis</i>	0%	NA	75-95%	Riparian area in depression near intermittent stream, riparian area is not along the stream itself.

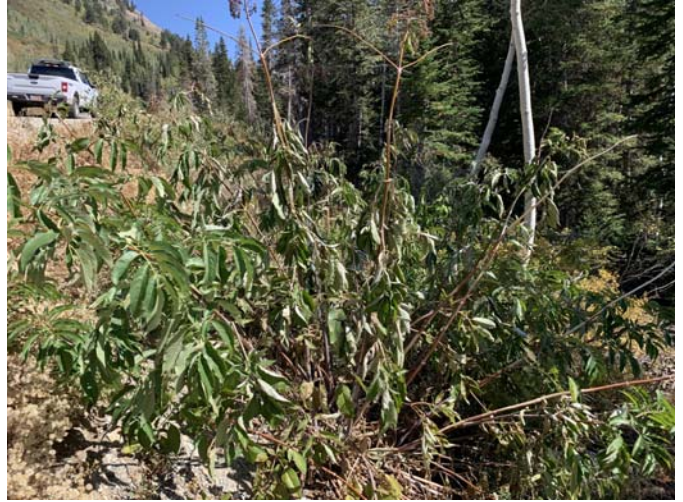
RHCA Field Point 7

7	JM	9/24/2020	Some disturbance from road gravel.	NO	Late	25-50%	<i>Pseudotsuga menziesii</i>	25-50%	<i>Symphoricarpos oreophilus</i> , <i>Artemisia tridentata</i>	5-25%	<i>Solidago canadensis</i> , <i>Asclepias syriaca</i>	0%	NA	50-75%	NA
8	JM	9/24/2020	Some roadside construction disturbance to site.	NO	Late	5-25%	<i>Pseudotsuga menziesii</i> , <i>Populus tremuloides</i>	50-75%	<i>Cercocarpus ledifolius</i> Nutt., <i>Symphoricarpos oreophilus</i>	5-25%	<i>Bromus inermis</i>	0%	NA	50-75%	NA
9	JM	9/24/2020	Some disturbance within plot from road stabilization.	NO	Late	25-50%	<i>Pseudotsuga menziesii</i>	25-50%	<i>Symphoricarpos oreophilus</i> , <i>Prunus virginiana</i>	Trace-5%	<i>Bromus inermis</i>	0%	NA	50-75%	NA
10	JM	9/24/2020	Gravel disturbance from road.	NO	Late	25-50%	<i>Acer grandidentatum</i> , <i>Populus tremuloides</i> , <i>Pseudotsuga menziesii</i>	25-50%	<i>Symphoricarpos oreophilus</i> , <i>Rosa woodsii</i>	5-25%	<i>Solidago canadensis</i> , <i>Thinopyrum ponticum</i> , <i>Bromus inermis</i>	0%	NA	50-75%	NA

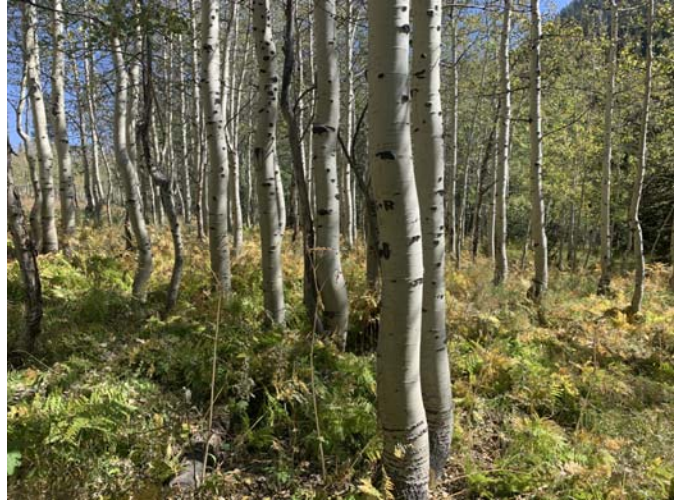
RHCA Field Point 11

11	JM	9/24/2020	No disturbance within plot.	NO	Late	25-50%	<i>Populus tremuloides</i> , <i>Pseudotsuga menziesii</i>	0%	NA	50-75%	<i>Bromus inermis</i>	0%	NA	75-95%	NA
13	JM	9/24/2020	Gravel disturbance from roadside.	NO	Mid	25-50%	<i>Populus tremuloides</i>	25-50%	<i>Symphoricarpos oreophilus</i>	5-25%	<i>Pseudoroegneria spicata</i> , <i>Bromus inermis</i> ,	0%	NA	50-75%	NA

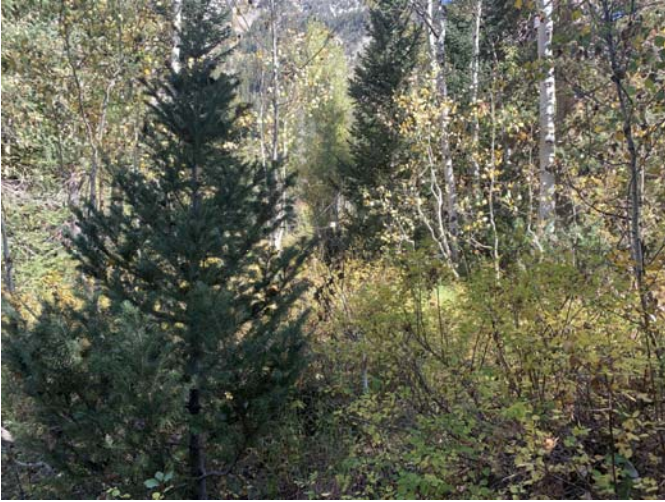
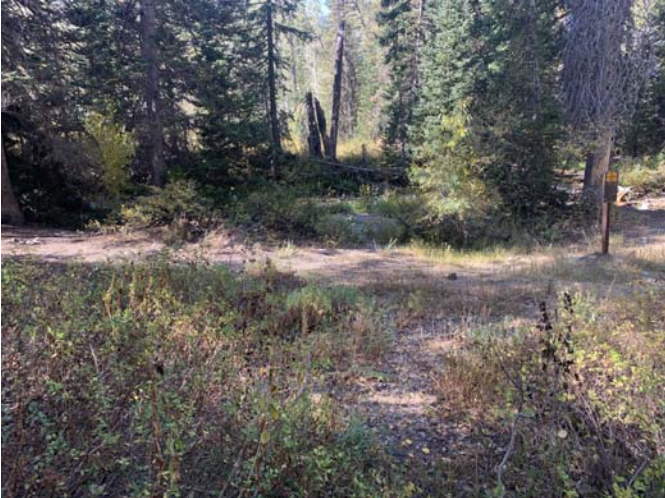
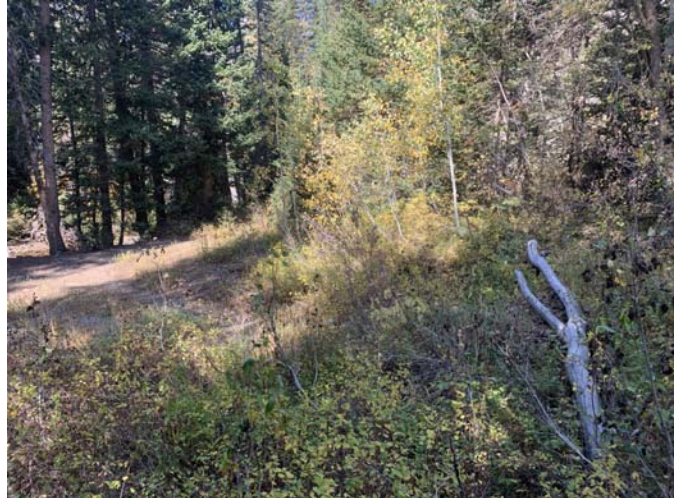
RHCA Field Point 15

<i>Solidago canadensis</i>				
15	JMMP	9/24/2020	Disturbance within plot due to trails.	NO	Late	5-25%	<i>Populus tremuloides, Pseudotsuga menziesii</i>	50-75%	<i>Symphoricarpos oreophilus</i>	5-25%	<i>Asclepias syriaca</i>	0%	NA	50-75%	Stream appears to be in good condition.
18	MP	9/24/2020	No evidence of disturbance in plot.	NO	Late	50-75%	<i>Pseudotsuga menziesii, Populus tremuloides</i>	50-75%	<i>Symphoricarpos oreophilus, Paxistima myrsinites</i>	Trace-5%	<i>Aquilegia sp.</i>	0%	NA	5-25%	NA
19	MP	9/24/2020	No evidence of disturbance observed.	NO	Late	25-50%	<i>Pseudotsuga menziesii, Populus tremuloides</i>	75-95%	<i>Salix wolfii, Populus tremuloides</i>	0%	NA	0%	NA	25-50%	NA
22	MP	9/24/2020	Steep roadside slope with some reclaimed grassland.	NO	Late	25-50%	<i>Acer negundo, Acer grandidentatum, Pseudotsuga menziesii</i>	25-50%	<i>Prunus virginiana, Acer grandidentatum</i>	25-50%	<i>Bromus inermis, Thinopyrum ponticum</i>	0%	NA	25-50%	NA

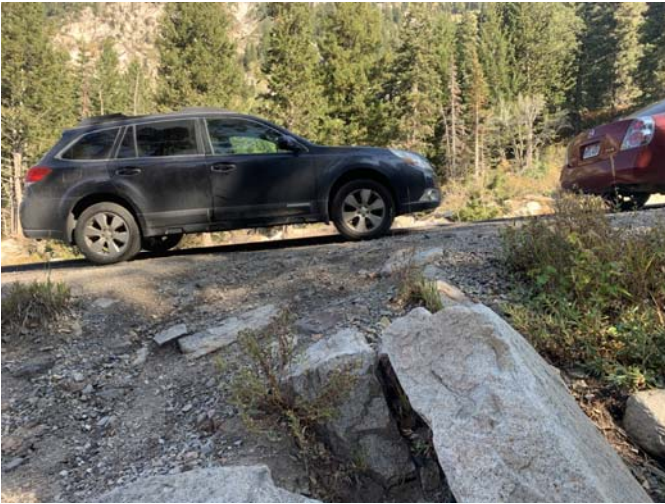
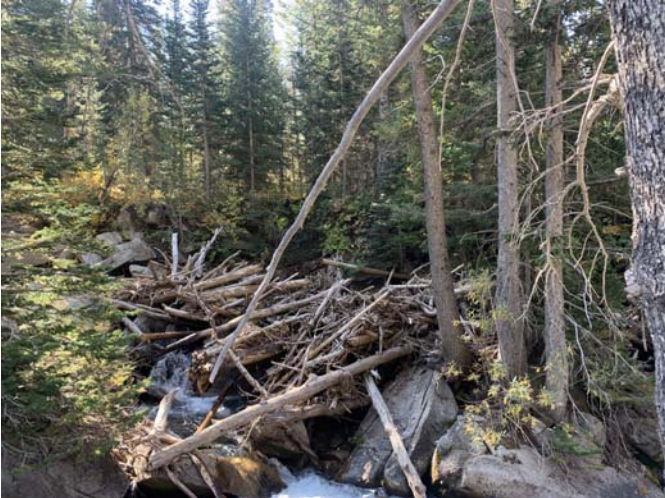
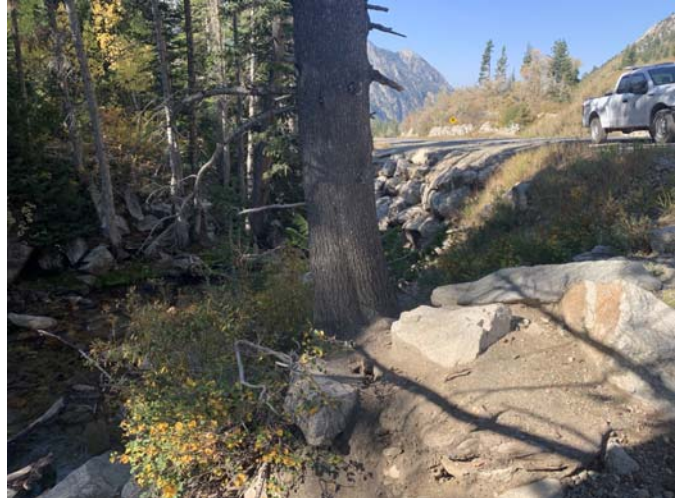
RHCA Field Point 16

16	JMMP	9/24/2020	Stabilized for road shoulder and informal trail within plot.	Yes	Late	25-50%	<i>Pseudotsuga menziesii</i>	5-25%	<i>Salix bebbiana</i> , <i>Lonicera involucrata</i> , <i>Ribes aureum</i>	5-25%	<i>Bromus inermis</i> , <i>Solidago canadensis</i>	0%	NA	25-50%	Some disturbance from road stabilization boulders. Aside from that, stream appears to be in good condition.

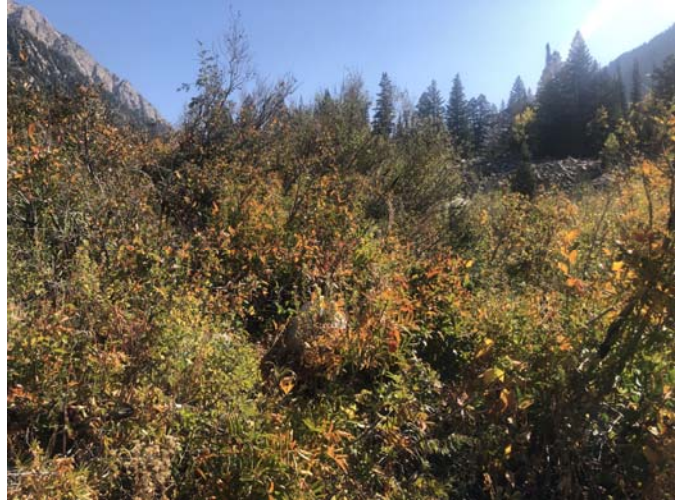
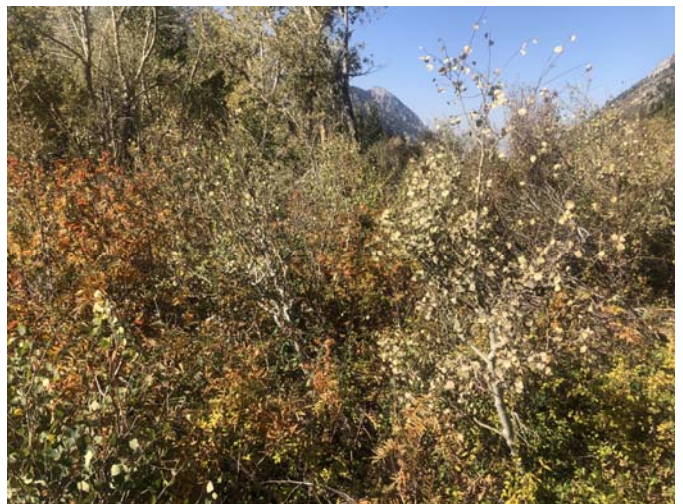
RHCA Field Point 17

17	MP	9/24/2020	Plot in riparian area, into base of road shoulder whereas upper shoulder is non-riparian.	Yes	Mid	0%	NA	75-95%	<i>Fraxinus americana</i> , <i>Populus angustifolia</i> , <i>Prunus virginiana</i> , <i>Symphoricarpos oreophilus</i> , <i>Populus tremuloides</i>	5-25%	<i>Solidago canadensis</i> , <i>Bromus inermis</i> , <i>Grindelia squarrosa</i>	0%	NA	5-25%	Appears undisturbed just south of plot.
20	MP	9/24/2020	Evidence of ground disturbance from road shoulder and channel work.	Yes	Late	25-50%	<i>Acer negundo</i> , <i>Populus angustifolia</i> , <i>Pseudotsuga menziesii</i>	50-75%	<i>Symphoricarpos oreophilus</i> , <i>Acer negundo</i> , <i>Pseudotsuga menziesii</i>	25-50%	<i>Solidago canadensis</i>	0%	NA	5-25%	Intermittent, currently dry. Evidence of channel work from storm flooding to repair road drainage.
21	MP	9/24/2020	No cottonwoods. Somewhat disturbed as plot is at toe of road slope. Informal trail.	Yes	Late	50-75%	<i>Acer negundo</i> , <i>Pseudotsuga menziesii</i>	25-50%	<i>Salix wolfii</i> , <i>Acer negundo</i>	25-50%	<i>Bromus inermis</i>	0%	NA	5-25%	Relatively new road drainage culverts.

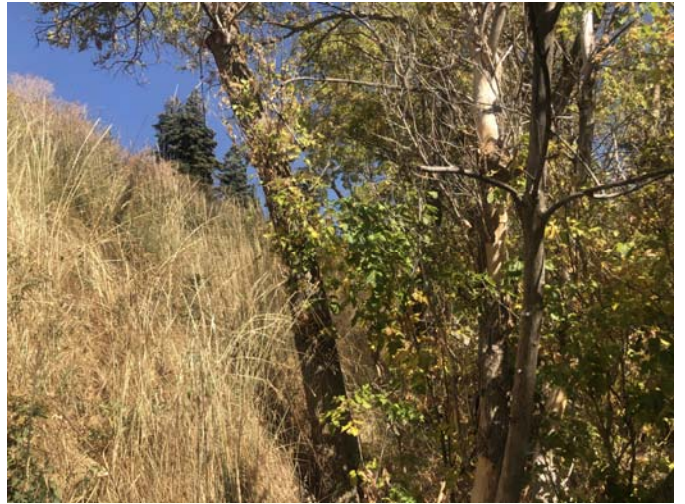
RHCA Field Point 22

22	MP	9/24/2020	Reclaimed road slope with wheatgrass. Just below is oak-maple community.	NO	Mid	0%	NA	0%	NA	75-95%	<i>Thinopyrum ponticum, Ambrosia artemisiifolia</i>	5-25%	<i>Ambrosia artemisiifolia</i>	5-25%	NA
23	MP	9/24/2020	Plot on roadside slope.	NO	Mid	5-25%	<i>Quercus gambelii, Acer grandidentatum</i>	5-25%	<i>Prunus virginiana, Acer grandidentatum</i>	25-50%	<i>Ribes aureum, Thinopyrum ponticum, Bromus tectorum</i>	5-25%	<i>Bromus tectorum</i>	5-25%	NA
23	MP	9/24/2020	Steep road slope with reclaimed grasses.	NO	Mid	0%	NA	5-25%	<i>Ericameria nauseosa</i>	25-50%	<i>Thinopyrum ponticum, Symphyotrichum sp.</i>	0%	NA	25-50%	NA
24	MP	9/24/2020	Plot on a road cut with some erosion.	NO	Mid	0%	NA	5-25%	<i>Quercus gambelii, Acer grandidentatum</i>	25-50%	<i>Symphyotrichum sp., Achillea millefolium</i>	0%	NA	50-75%	NA
25	MP	9/24/2020	Some evidence of rock slope stabilization.	NO	Late	75-95%	<i>Acer grandidentatum</i>	25-50%	<i>Prunus virginiana</i>	Trace-5%	<i>Thinopyrum ponticum</i>	Trace-5%	<i>Bromus tectorum</i>	25-50%	NA

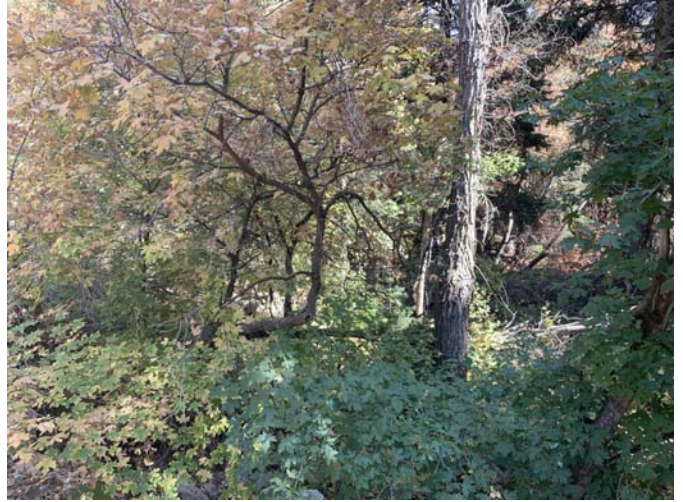
RHCA Field Point 26

26	JM	9/24/2020	Site has some gravel disturbance from road.	NO	Late	50-75%	<i>Pseudotsuga menziesii, Acer grandidentatum</i>	25-50%	<i>Prunus virginiana, Symphoricarpos oreophilus, Ericameria nauseosa</i>	5-25%	<i>Grindelia squarrosa</i>	0%	NA	50-75%	NA
27	JM	9/24/2020	Site not disturbed.	NO	Late	50-75%	<i>Pseudotsuga menziesii, Acer grandidentatum</i>	5-25%	<i>Acer grandidentatum, Prunus virginiana</i>	Trace-5%	<i>Thinopyrum ponticum</i>	0%	NA	25-50%	NA

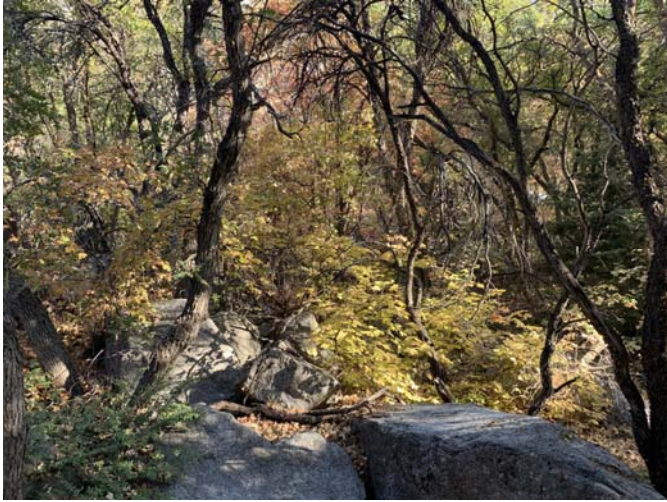
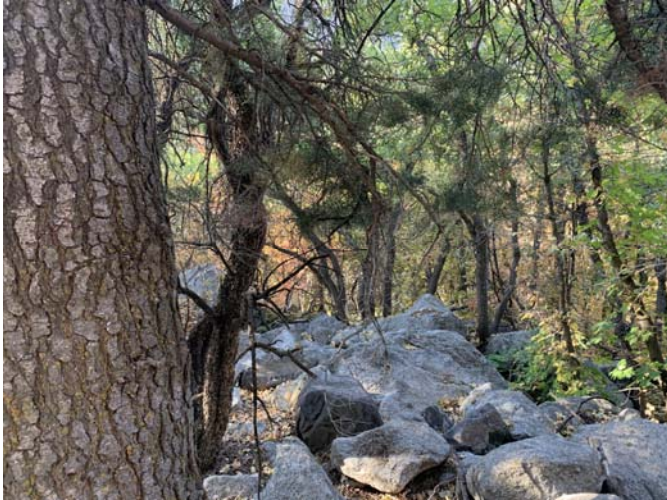
RHCA Field Point 28

28	JMAC	9/25/2020	Disturbance within plot with mountain biking trails.	NO	Late	50-75%	<i>Quercus gambelii</i> , <i>Acer grandidentatum</i> , <i>Pseudotsuga menziesii</i>	25-50%	<i>Paxistima myrsinites</i> , <i>Acer grandidentatum</i> , <i>Mahonia aquifolium</i>	0%	NA	0%	NA	50-75%	NA
29	JMAC	9/25/2020	Large intermittent stream within plot.	NO	Late	25-50%	<i>Pseudotsuga menziesii</i> , <i>Quercus gambelii</i> , <i>Acer grandidentatum</i>	5-25%	<i>Mahonia aquifolium</i> , <i>Paxistima myrsinites</i>	0%	NA	0%	NA	50-75%	NA
30	JMAC	9/25/2020	Stream causes some disturbance within plot.	NO	Late	50-75%	<i>Pseudotsuga menziesii</i> , <i>Quercus gambelii</i>	25-50%	<i>Acer grandidentatum</i> , <i>Pseudotsuga menziesii</i>	0%	NA	0%	NA	50-75%	NA
31	JMAC	9/25/2020	Hill slope off the side of S.R. 210.	NO	Late	25-50%	<i>Acer grandidentatum</i>	25-50%	<i>Acer grandidentatum</i> , <i>Mahonia aquifolium</i>	50-75%	<i>Bromus inermis</i>	0%	NA	75-95%	NA

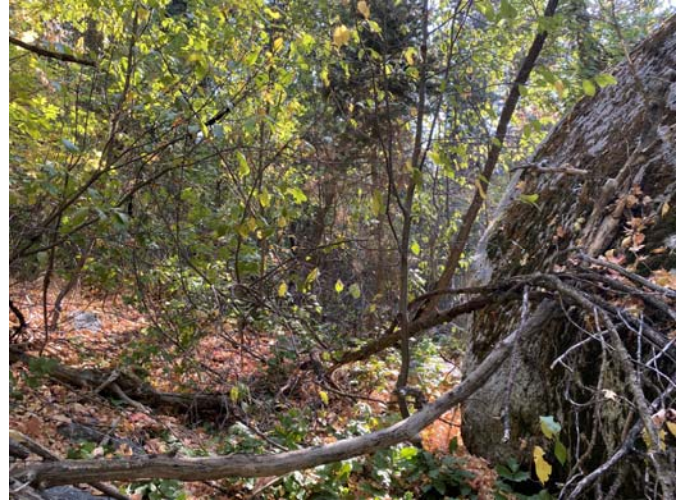
RHCA Field Point 32

32	JMAC	9/25/2020	Boxelder and larger trees downslope.	NO	Late	50-75%	<i>Acer grandidentatum</i> , <i>Pseudotsuga menziesii</i>	25-50%	<i>Acer grandidentatum</i> , <i>Mahonia aquifolium</i> , <i>Lonicera involucrata</i>	25-50%	<i>Bromus inermis</i>	0%	NA	95-100%	NA
33	JMAC	9/25/2020	Point taken from side of road. Steep hill slope.	NO	Late	25-50%	<i>Quercus gambelii</i> , <i>Acer negundo</i>	25-50%	<i>Acer negundo</i> , <i>Quercus gambelii</i>	5-25%	<i>Bromus inermis</i>	0%	NA	25-50%	NA
34	JMAC	9/25/2020	Steep hill slope.	NO	Late	25-50%	<i>Acer grandidentatum</i> , <i>Quercus gambelii</i>	5-25%	<i>Acer grandidentatum</i> , <i>Quercus gambelii</i> , <i>Prunus virginiana</i>	5-25%	<i>Grindelia squarrosa</i>	NA	NA	25-50%	NA
35	JMAC	9/25/2020	Just off hill slope of road.	NO	Late	25-50%	<i>Acer grandidentatum</i>	5-25%	<i>Mahonia aquifolium</i>	5-25%	<i>Bromus inermis</i>	0%	NA	50-75%	NA
36	JM	9/29/2020	Site does not appear to be disturbed.	NO	Late	50-75%	<i>Acer negundo</i> , <i>Acer grandidentatum</i>	5-25%	<i>Ericameria nauseosa</i> , <i>Prunus virginiana</i>	5-25%	<i>Bromus inermis</i> , <i>Thinopyrum ponticum</i>	0%	NA	50-75%	NA

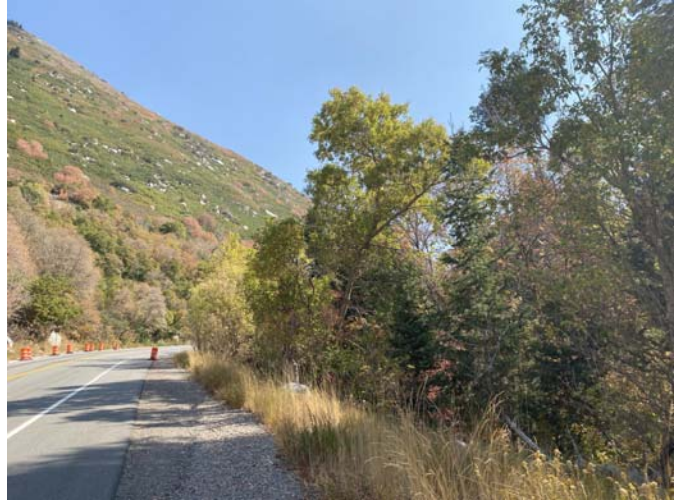
RHCA Field Point 37

37	JMAC	9/25/2020	Steep hill slope.	NO	Late	50-75%	<i>Quercus gambelii</i> , <i>Acer grandidentatum</i>	50-75%	<i>Quercus gambelii</i> , <i>Acer grandidentatum</i>	5-25%	<i>Grindelia squarrosa</i> , <i>Bromus inermis</i>	0%	NA	50-75%	NA
39	JM	9/25/2020	Site is not disturbed.	NO	Late	50-75%	<i>Acer grandidentatum</i> , <i>Acer negundo</i>	50-75%	<i>Mahonia aquifolium</i>	0%	NA	0%	NA	50-75%	NA

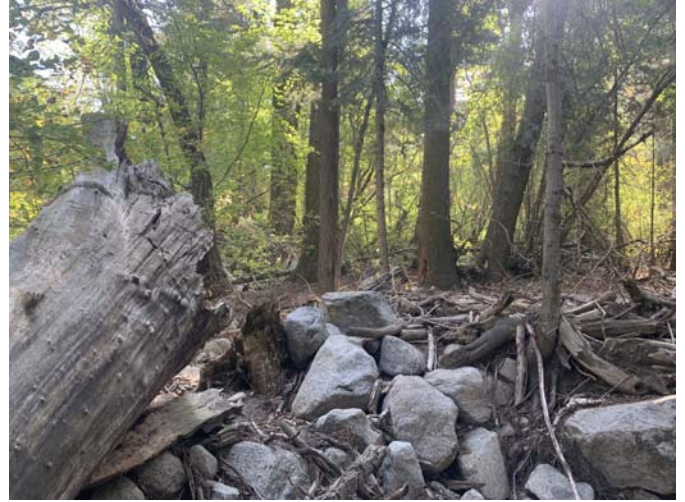
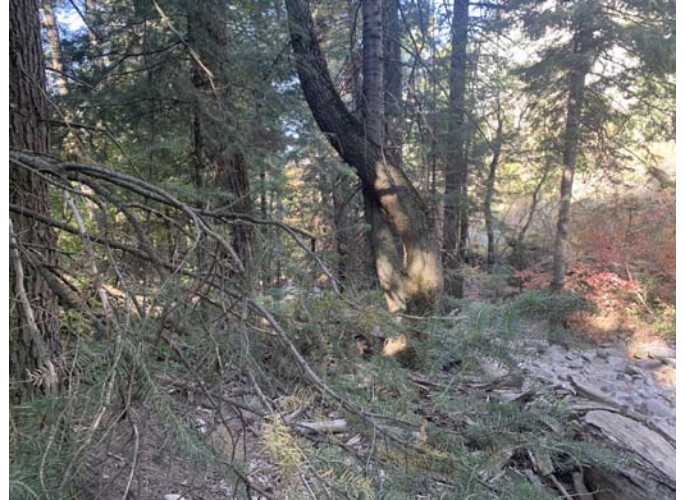
RHCA Field Point 38

38	JM	9/25/2020	Site is disturbed by large intermittent stream.	Yes	Late	50-75%	<i>Pseudotsuga menziesii</i> , <i>Populus angustifolia</i>	5-25%	<i>Acer grandidentatum</i> , <i>Cornus sericea</i>	0%	NA	0%	NA	50-75%	Disturbance and debris from runoff area.
40	JM	9/25/2020	Disturbance from road stabilization.	Yes	Late	5-25%	<i>Acer negundo</i>	5-25%	<i>Paxistima myrsinites</i>	5-25%	<i>Thinopyrum ponticum</i>	0%	NA	25-50%	Stream is disturbed from road stabilization. Thin riparian layer about 10 feet north of the stream.
41	JM	9/25/2020	The stream has eroded the banks within the plot.	Yes	Late	25-50%	<i>Acer grandidentatum</i> , <i>Populus angustifolia</i> , <i>Acer negundo</i>	25-50%	<i>Cornus sericea</i> , <i>Paxistima myrsinites</i>	Trace-5%	<i>Thinopyrum ponticum</i>	0%	NA	50-75%	Stream has eroded banks, but is in good condition aside from that.
42	JM	9/25/2020	Plot near roadside, some road disturbance.	Yes	Late	50-75%	<i>Populus angustifolia</i> , <i>Acer grandidentatum</i>	50-75%	<i>Cornus sericea</i>	5-25%	<i>Bromus inermis</i> , <i>Grindelia squarrosa</i>	0%	NA	50-75%	Stream is in good condition aside from eroded banks.

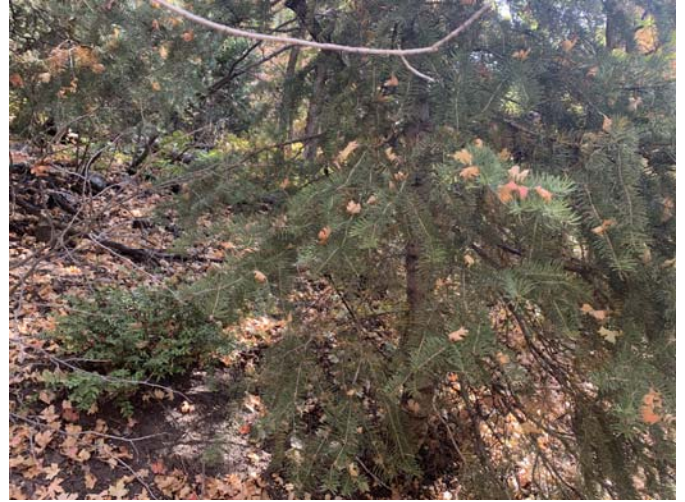
RHCA Field Point 43

43	JM	9/25/2020	No disturbance within area.	NO	Late	25-50%	<i>Acer grandidentatum</i> , <i>Pseudotsuga menziesii</i>	5-25%	<i>Prunus virginiana</i> , <i>Paxistima myrsinites</i>	0%	NA	0%	NA	25-50%	NA
44	MP	9/25/2020	Informal trails in plot.	NO	Late	50-75%	<i>Acer grandidentatum</i> , <i>Pseudotsuga menziesii</i>	25-50%	<i>Prunus virginiana</i> , <i>Acer grandidentatum</i>	25-50%	<i>Rubus parviflorus</i> , <i>Bromus inermis</i>	0%	NA	25-50%	Some erosion on north bank and pipe at top of bank.
45	JM	9/25/2020	Some gravel from road shoulder.	NO	Late	25-50%	<i>Quercus gambelii</i> , <i>Acer grandidentatum</i>	5-25%	<i>Quercus gambelii</i>	50-75%	<i>Bromus inermis</i>	0%	NA	50-75%	NA
46	JM	9/25/2020	Site has disturbance from recreational activity.	NO	Late	50-75%	<i>Acer grandidentatum</i> , <i>Quercus gambelii</i>	25-50%	<i>Mahonia aquifolium</i> , <i>Prunus virginiana</i>	0%	NA	0%	NA	50-75%	NA
47	JM	9/25/2020	Disturbance from road gravel.	NO	Late	50-75%	<i>Acer grandidentatum</i> , <i>Acer negundo</i>	5-25%	<i>Ericameria nauseosa</i>	5-25%	<i>Grindelia squarrosa</i> , <i>Asclepias syriaca</i>	0%	NA	25-50%	NA

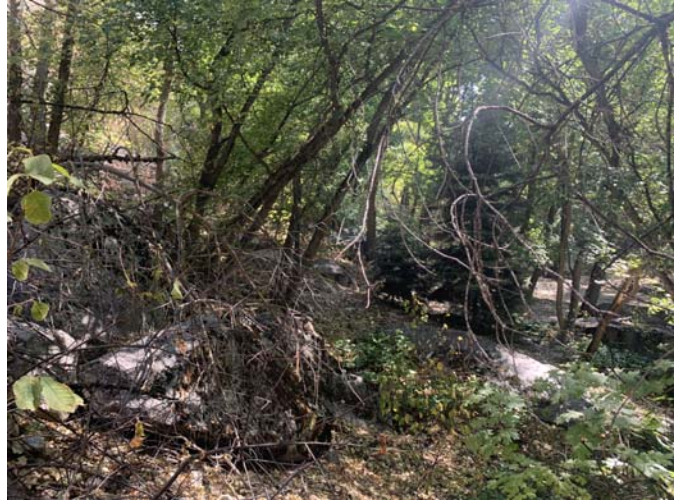
RHCA Field Point 48

48	JM	9/25/2020	Some trails throughout plot.	NO	Late	50-75%	<i>Acer grandidentatum</i> , <i>Pseudotsuga menziesii</i>	25-50%	<i>Mahonia aquifolium</i> , <i>Prunus virginiana</i>	0%	NA	0%	NA	25-50%	NA
49	JMAC	9/25/2020	Some road disturbance at site.	NO	Late	50-75%	<i>Acer grandidentatum</i> , <i>Quercus gambelii</i>	25-50%	<i>Ericameria nauseosa</i> , <i>Lonicera involucrata</i>	0%	NA	0%	NA	50-75%	NA
50	JM	9/25/2020	No disturbance within site.	NO	Late	25-50%	<i>Acer grandidentatum</i>	50-75%	<i>Acer grandidentatum</i> , <i>Prunus virginiana</i> , <i>Mahonia aquifolium</i>	Trace-5%	<i>Thinopyrum ponticum</i>	0%	NA	50-75%	NA
51	JM	9/25/2020	Popular trail runs through site.	NO	Late	25-50%	<i>Acer grandidentatum</i>	5-25%	<i>Ericameria nauseosa</i>	5-25%	<i>Thinopyrum ponticum</i>	0%	NA	25-50%	NA
52	JMAC	9/25/2020	Construction ongoing at site.	NO	Late	50-75%	<i>Quercus gambelii</i> , <i>Acer grandidentatum</i>	25-50%	<i>Prunus virginiana</i> , <i>Acer grandidentatum</i>	0%	NA	0%	NA	50-75%	NA

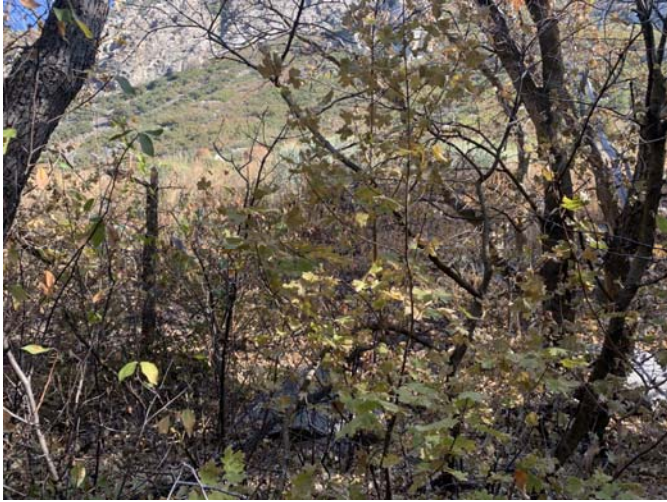
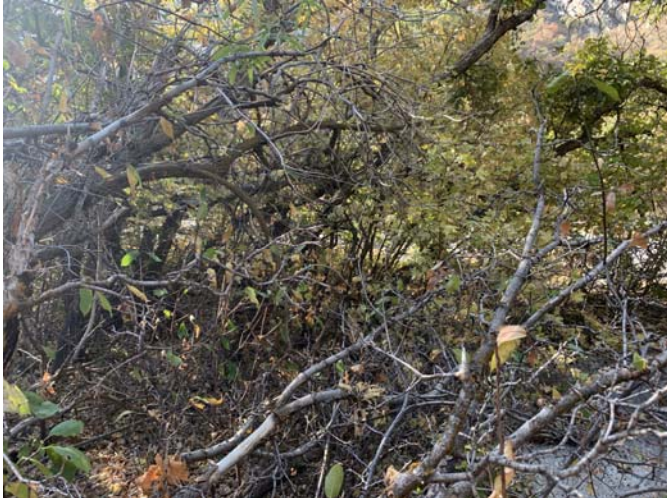
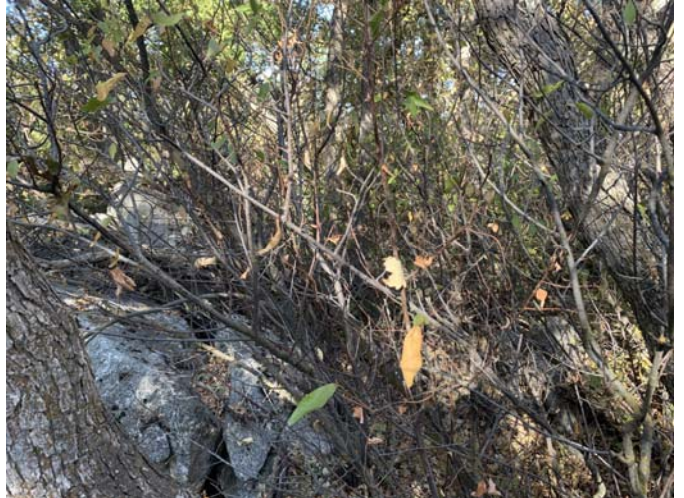
RHCA Field Point 53

53	JMMP	9/24/2020	The disturbance observed in the plot.	NO	Late	25-50%	<i>Quercus gambelii</i>	5-25%	<i>Prunus virginiana</i>	0%	NA	0%	NA	25-50%	NA
54	JMMP	9/24/2020	No disturbance observed in plot.	NO	Late	5-25%	<i>Quercus gambelii</i> , <i>Acer grandidentatum</i>	25-50%	<i>Ericameria nauseosa</i> , <i>Artemisia tridentata</i> , <i>Prunus virginiana</i>	5-25%	<i>Bromus inermis</i>	0%	NA	25-50%	NA
